Following a detailed inspection, all machines were setup and booted to Sugar. Then rebooted into a looping configuration of the on board diagnostics. All machines operated for about three weeks with NO functional failures. After several days of operation, teardown inspections were started and a total of 10 machines were broken down completely and inspected in detail.

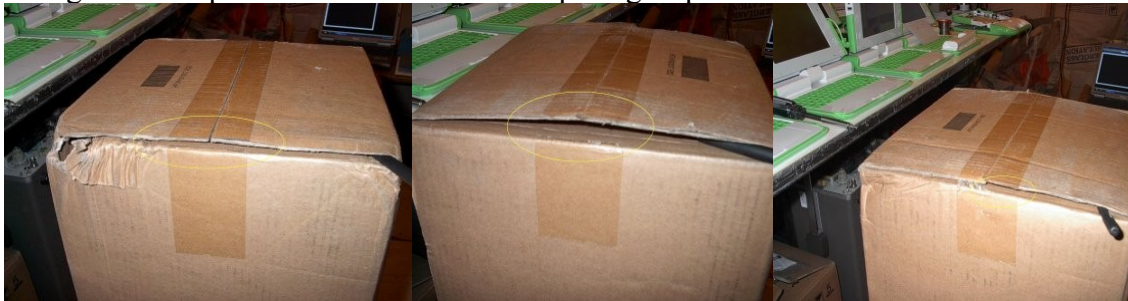
One box was damaged in shipment but the packaging protected the products very well with no product damage. However, two of the four boxes had broken tape across the bottom of the box. This bottom seal of the carton is much too weak and needs to be strengthened to prevent carton failure and spilling of product.

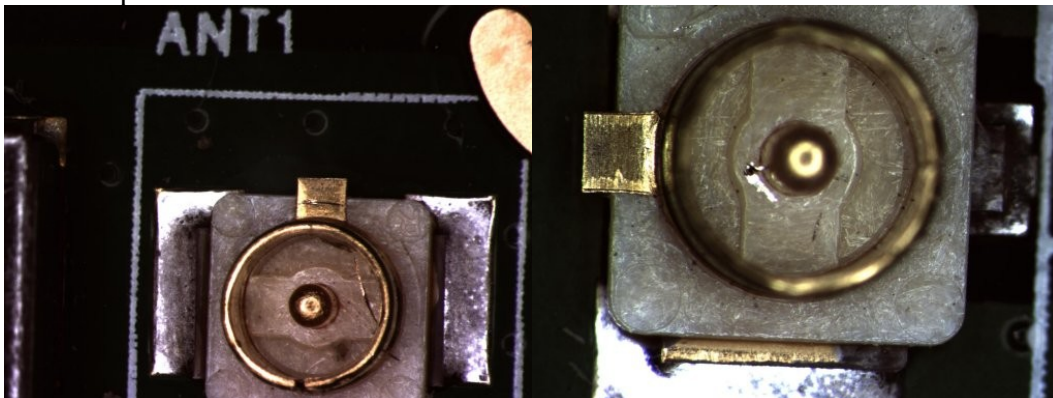
There were several observations regarding connectors. Beginning with the WiFi antenna connectors. There were two combinations. The connectors on the board were always gold plated. There were two different vendors for the female connector used on the cable, one was gold plated and one looked tin plated. Of the four machines with a tin on gold connector combination, there were six metal slivers in or around the ANT1 and ANT2 connectors on the board. These slivers appear to be shavings of plating material. Of the six machines using gold on gold connectors, only two very small slivers were found. These clearly caused no problems but they do have the potential to do so.

Several connector pairs have mismatched plating types, with gold on one side and tin on the other. And pairs are inconsistent with gold on gold in some machines while tin on gold in others. Gold flash is possible in some that appear tin, but it was not observed. This may be a supply issue but if you are paying for gold, you should get gold.

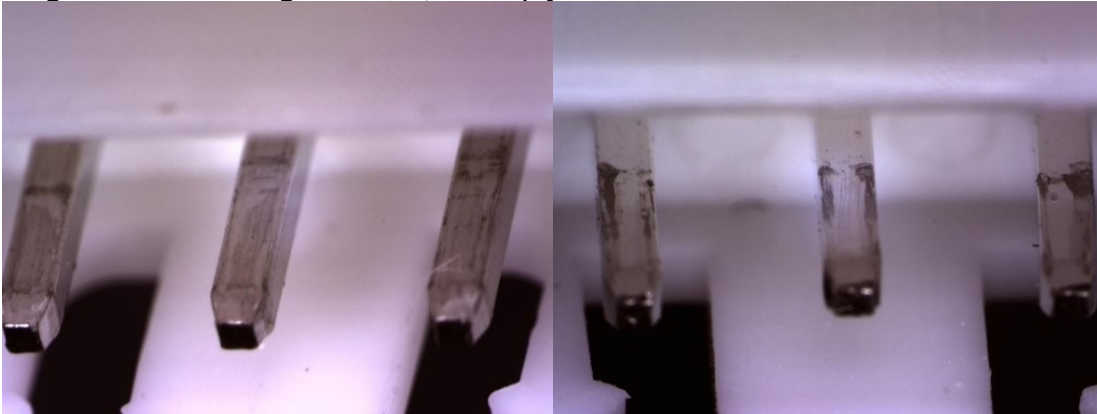
This brings up the potential of fretting corrosion on the tin on tin connectors (or tin on gold for that matter). The battery cable to cable connector mounted under the handle is a good example. Photos of this connector show dark deposits of tin oxide present which is a sign of either fretting corrosion, or simply oxidized tin resulted from the first insertion.

Machines which have experienced vibration and/or thermal cycling, should be disassembled and inspected for signs of fretting corrosion, especially on the battery cable connector. The floating nature of this design should prevent relative motion, and is good practice. Still, a resistance check and visual inspection of connectors from thermal and vibration test machines, will be important to verify the design.

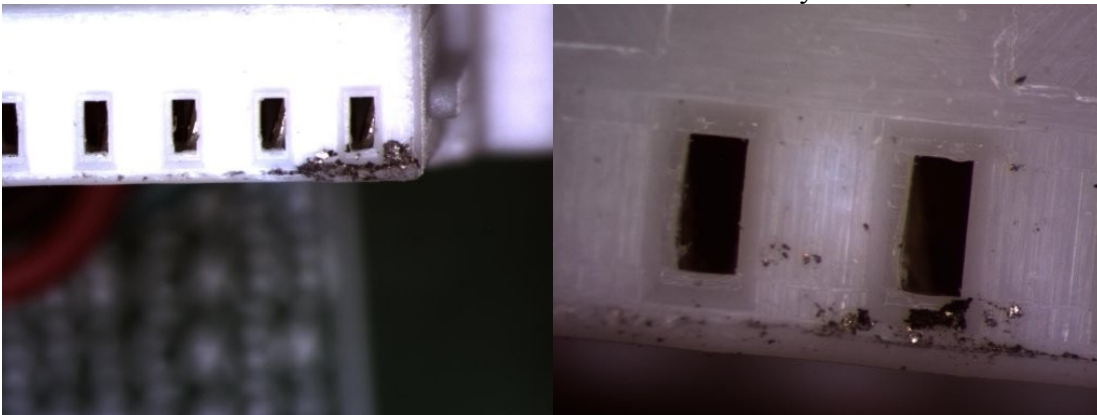
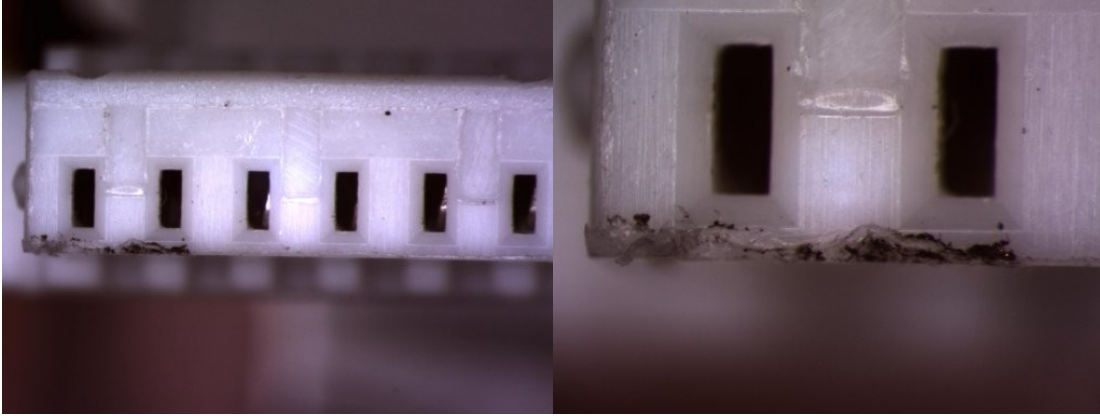
Three machines had what appears to be solder and flux debris on the female side of CN23. Interestingly, there was no debris inside the male housings. Finding three examples in a small sample of only 10 machines, says there is probably an issue with cleanliness of a work area that handles this connector. Possibly a cable tester.

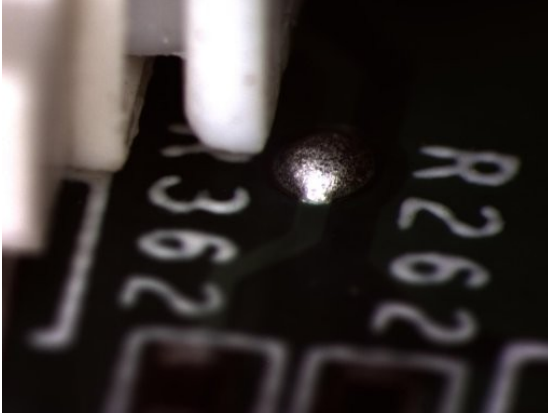
Connectors CN25 and CN26 are identical to CN22. Removing the cables from CN25 and CN26 is straight forward. However, removing the cable from CN22 is made more difficult by the solder bump from a feed through just in front of the female end.

The locking detent feature is a bump on the bottom of the female connector and when pulled out, the detent needs to ride up out of its notch and will tip the outside edge down. The solder bump interferes with this motion and makes it difficult to withdraw. The tendency to pull on the wires rather than the connector housing has the potential to damage the connector contact pins and/or the housing. This may be a service issue as well as an issue on the production line. When the opportunity is available, moving this solder bump slightly would be advised.

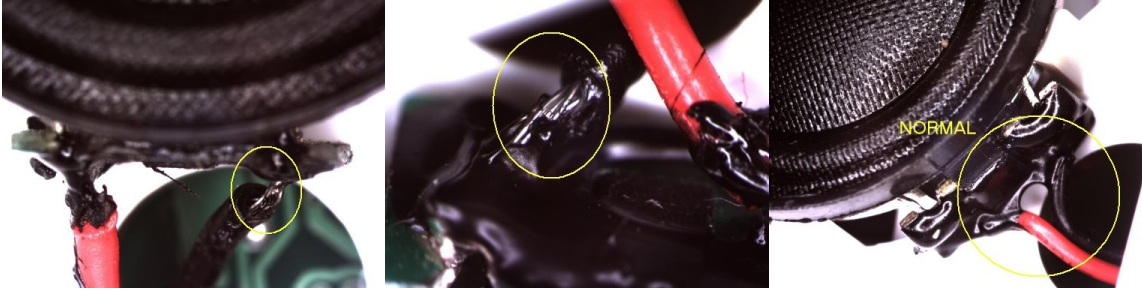
Another issue of pulling on wires to remove connectors, comes from a machine that had a production line mother board repair, the replacement LED D2. This required disassembly and board removal. Both sets of speaker wires appear to have been pulled on excessively to remove connectors CN25 and CN26. The speaker end of these cables has the solder joints covered with a soft black coating. I do not know the purpose for the coating over these connections. It is too soft to act as a strain relief. In this case, suspected tugging on these wires to remove connectors, has apparently damaged this sealing material. Unknown if this is a problem or not.

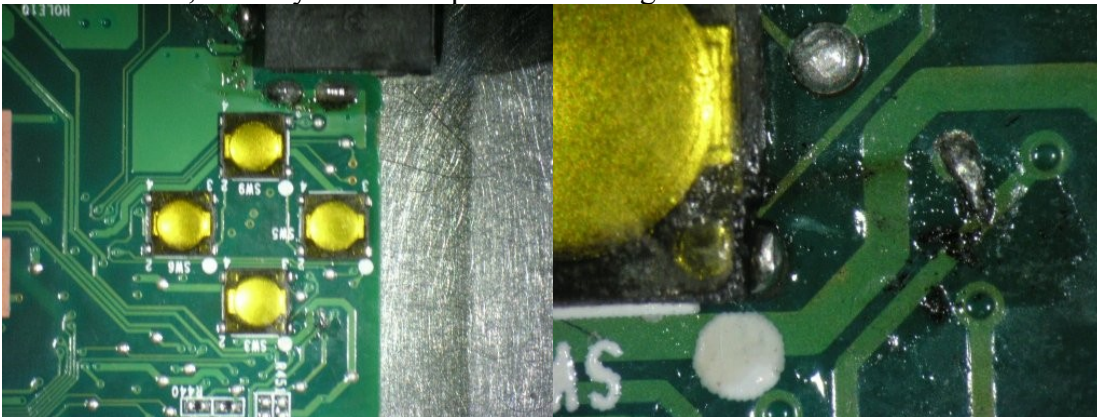
The large metal through hole mounting tabs for external connectors often require hand touch up to make sufficient solder joints. The soldering irons for this task are necessarily high power. In this case a solder splash from touchup of the DC input connector, fell in proximity to the scroll pad switches, either landing on or near switch SW3. When the same high power iron was used to remove the solder splash, it partially melted the housing on SW3. No functional problem resulted. However, operators should be instructed to do clean up work with a much smaller, low power soldering iron to avoid component damage. Two other similar solder splashes during through hole touch up were observed, but they caused no potential damage.

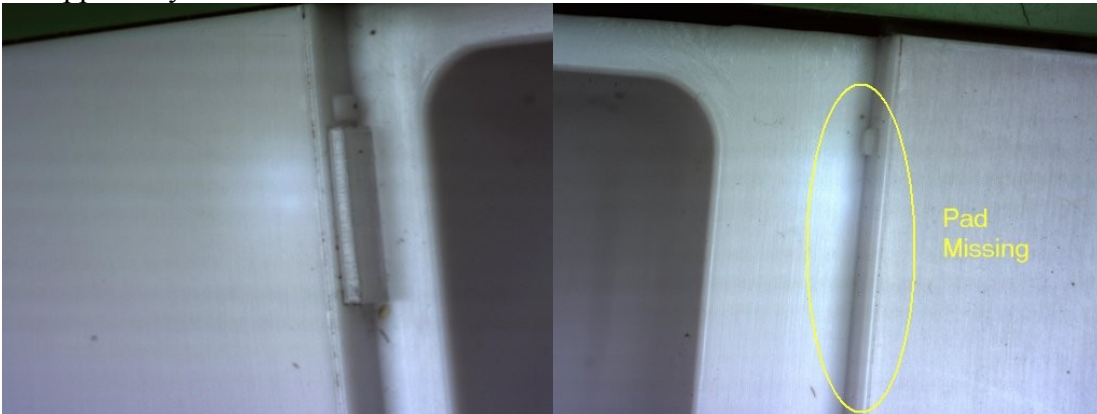
In the battery compartment, one machine had a missing spacer. These are small pads that are apparently attached with adhesive.

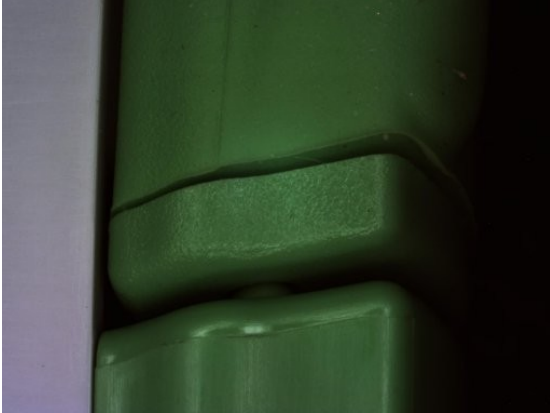
Gaps observed in some antennas, same as ticket #2251
